American Home Inspections of NE NC

Property Address US Coast Guard Housing, Unit #46017

Inspector Name Ralph W. Woodard, NC Licensed Home Inspector #493
Company Name American Home Inspections of NE NC
Company Address PO Box 2347
City Kitty Hawk State NC Zip 27949
Phone Cell 25 202 8344 Fax x
E-Mail ralphdubya@embargmail.com

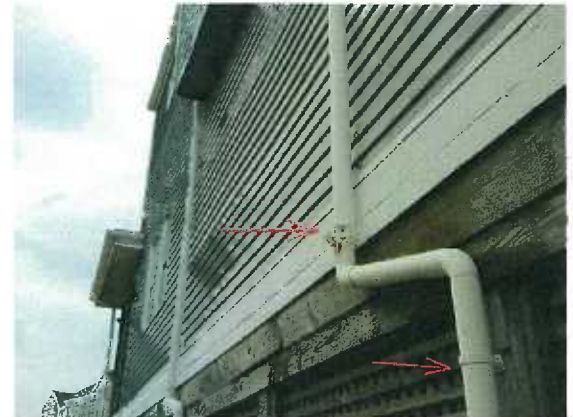
9. ☒ ☐ ☐ ☐ ☐ Gutters: Plastic
10. ☐ ☐ ☐ ☐ ☒ Downspouts: Plastic Parts of the gutter down spouts are missing and not properly attached to the building.

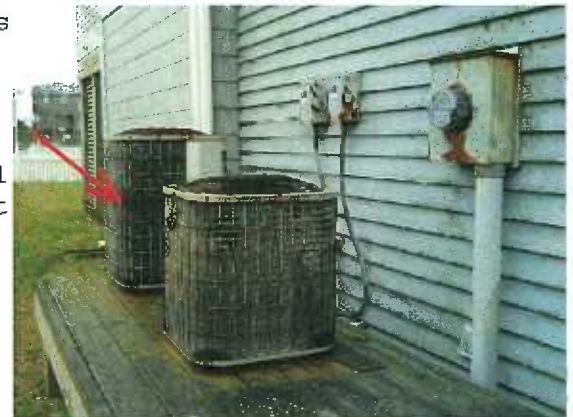
1. ☐ ☐ ☐ ☐ ☒ A/C System Operation: Inoperative The unit is nearing the end of the manufactures stated design life
2. ☒ ☐ ☐ ☐ ☐ Condensate Removal: Plastic tubing
3. ☒ ☐ ☐ ☐ ☐ Exterior Unit: Mounted on wooden platform
4. Manufacturer: Carrier
5. Area Served: Ground & Mid Levels Approximate Age: 12 to 14 years
6. Fuel Type: Electric Temperature Differential: x
7. Type: Heat pump Capacity: 2.5 ton
8. ☐ ☐ ☐ ☐ ☒ Visible Coil: Copper core with aluminum fins
The aluminum fins surrounding the copper coil are becoming deteriorated and falling away from the copper coil. The aluminum fins are present to dissipate the heat from the copper coil and when the fins are no longer present the coil will over heat and the condenser will cease to function.

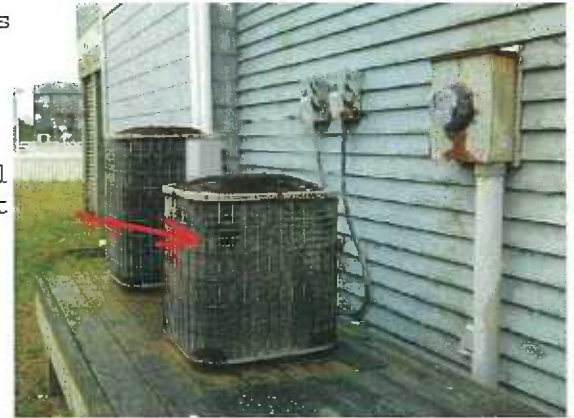
18. ☐☐☐☐☒ **Visible Coil:** Copper core with aluminum fins
The aluminum fins surrounding the copper coil are becoming deteriorated and falling away from the copper coil. The aluminum fins are present to dissipate the heat from the copper coil and when the fins are no longer present the coil will over heat and the condenser will cease to function.

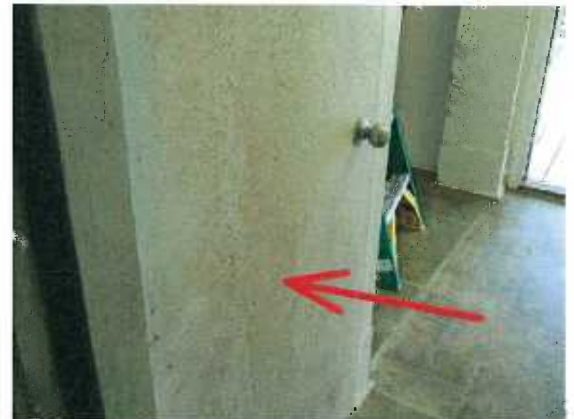
10. **Ground Level Utility/Storage Room Living Space Walls:** Paneling, Painted There is presence of organic growth on the painted plywood walls of this room.
11. **Ground Level Utility/Storage Room Living Space Doors:** Painted, Flush Solid Core There is organic growth on the surface of the door.

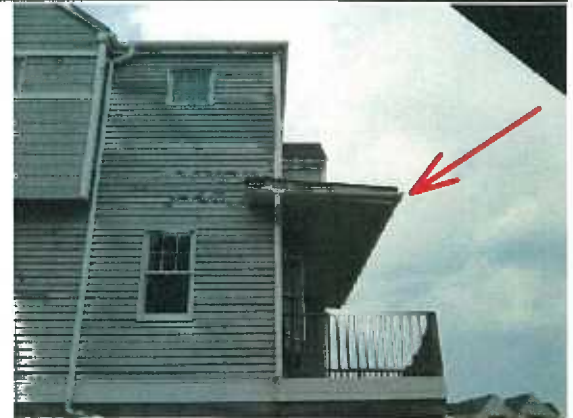
10. Foundation: 8X8 PT Wood Pilings and Monolithic Concrete Foundation The roof above the front deck, this roof is sloping downward at the outer edge. This condition probably exist because this is a single unit and there is no party wall to support the roof on the south side.

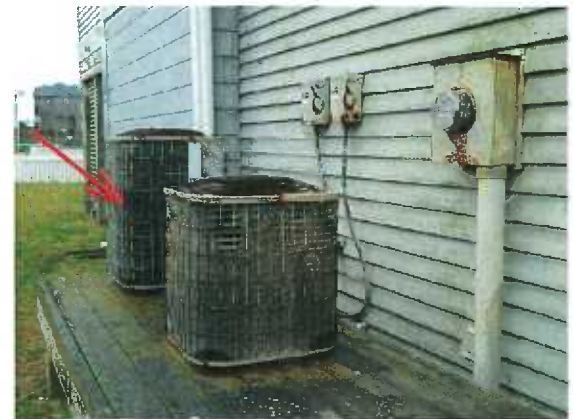
11. North Side AC System A/C System Operation: Inoperative The unit is nearing the end of the manufactures stated design life
12. North Side AC System Visible Coil: Copper core with aluminum fins The aluminum fins surrounding the copper coil are becoming deteriorated and falling away from the copper coil. The aluminum fins are present to dissipate the heat from the copper coil and when the fins are no longer present the coil will over heat and the condenser will cease to function.
13. North Side AC System Refrigerant Lines: Rubbertex Insulation The black rubbertex insulation on the copper tubing is deteriorated and should be replaced.
14. North Side AC System A/C System Operation: Inoperative The unit is currently in service beyond the manufactures stated design life

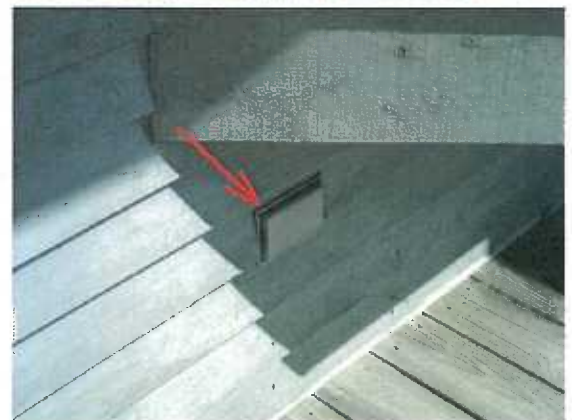
18. ☐ ☐ ☐ ☒ ☐ Exterior Electric Outlets: Exterior, Surface Mount There is an exterior outlet that is not properly installed in the wall opening.

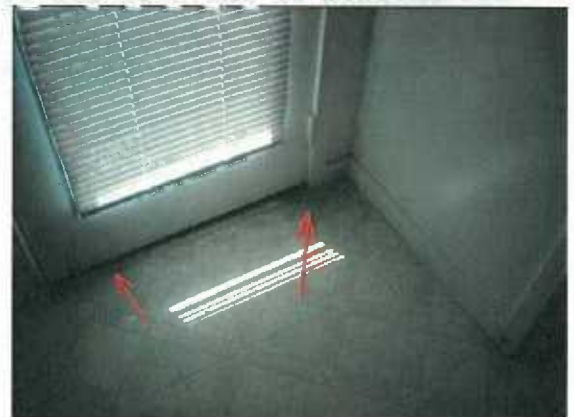
2. **Entry Door:** Kitchen/Dining Area, Fiberglass, Fullview Glass Moisture is migrating to the inside at the door threshold. The door and threshold need to be adjusted to stop the moisture migration.

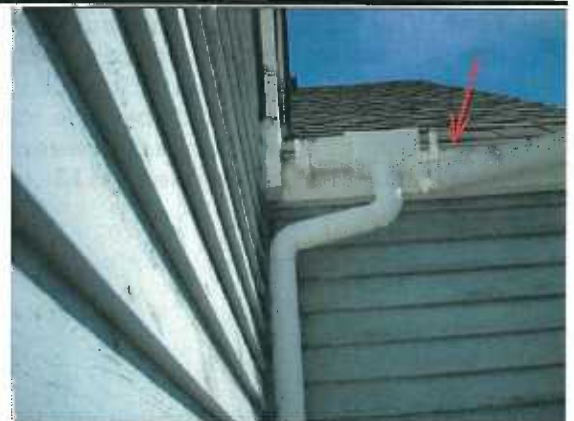
3. **Gutters:** Plastic The glue has failed at one of the sections of plastic gutter pipe. This is allowing moisture to fall into one of the corners of the party wall.

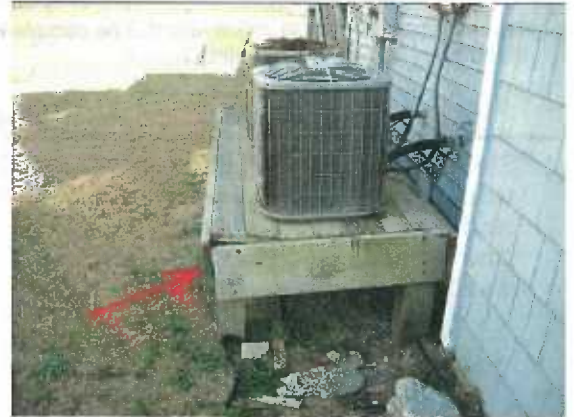
5. West Side AC System Exterior Unit: Mounted on wooden platform The wooden platform supporting the HVAC condensers has failed and should be repaired.

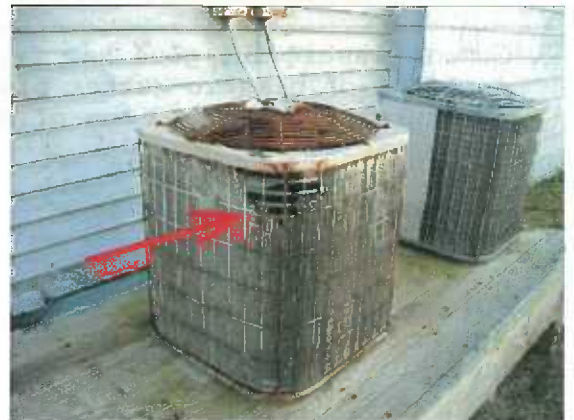
9. West Side AC System Visible Coil: Copper core with aluminum fins The aluminum fins surrounding the copper coil are becoming deteriorated and falling away from the copper coil. The aluminum fins are present to dissipate the heat from the copper coil and when the fins are no longer present the coil will over heat and the condenser will cease to function.

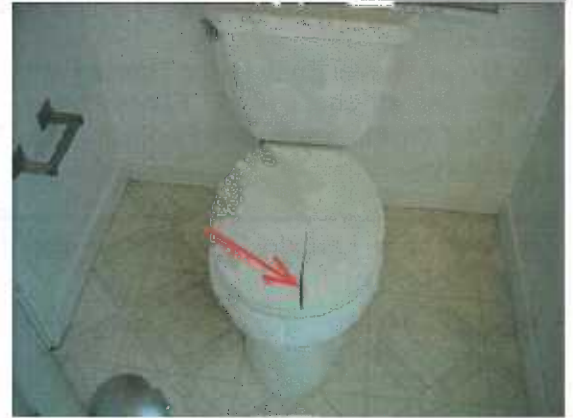
12. Main Level Powder Room Bathroom Toilets: Kohler The toilet seat lid is damaged.

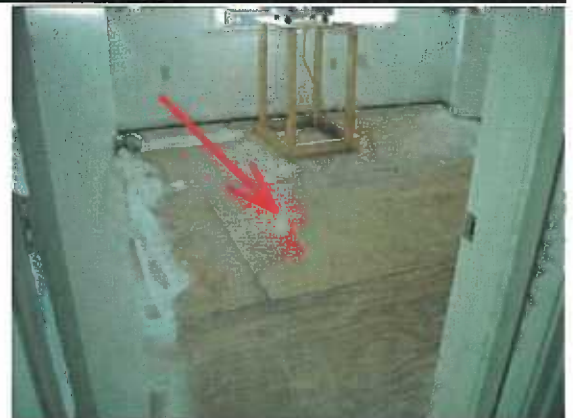
15. Top Rear Bedroom Floor: Carpet The carpet and padding has been removed from this room.

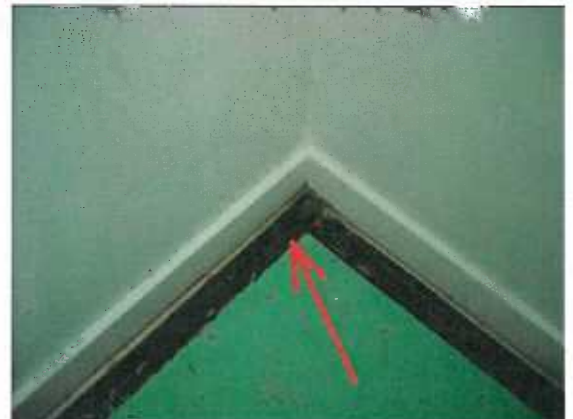
16. Top Front Bedroom Floor: Carpet The carpet is stained at the front left corner of the room in the area of the party wall.

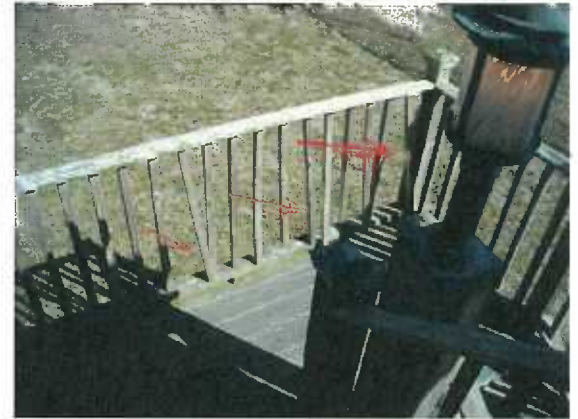
4. ☐ ☐ ☐ ☒ ☐ Stairs/Landing: RearStairs & Landing, Pressure Treated Wood The wood pickets are loose or out of place. The nails used to secure the pickets are rusty/deteriorated.

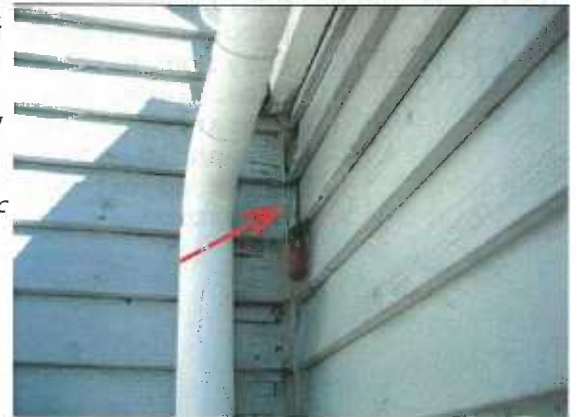
6. ☐ ☐ ☐ ☐ ☒ Type: Horizontal Wood Ship Lap Siding At the front, where the two units are joined, the siding and possibly the sub-siding and framing is deteriorated, All exterior wall surfaces should be examined and re nailed in the areas where is has become loose. The exterior of the house should be pressure washed and repainted.

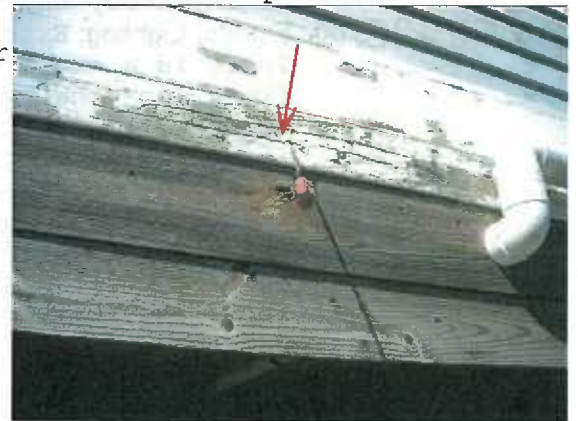
8. ☐ ☐ ☐ ☐ ☒ Trim: Wood, Aluminum Covered There is one piece of 2X4 wood trim at the lower front left corner, east side that is deteriorated and should be replaced.

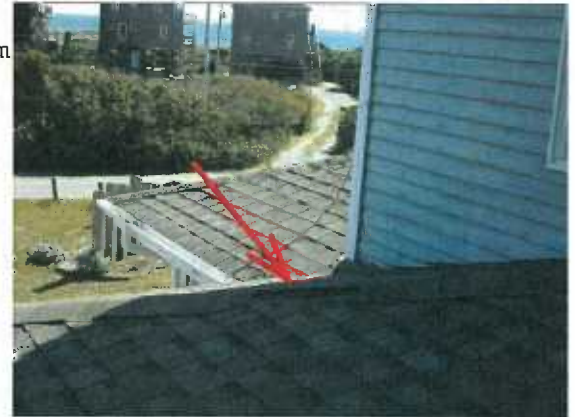
2. ☐ ☐ ☐ ☒ ☐ Material: Asphalt shingle There are several ridge cap shingles missing from the porch roof.

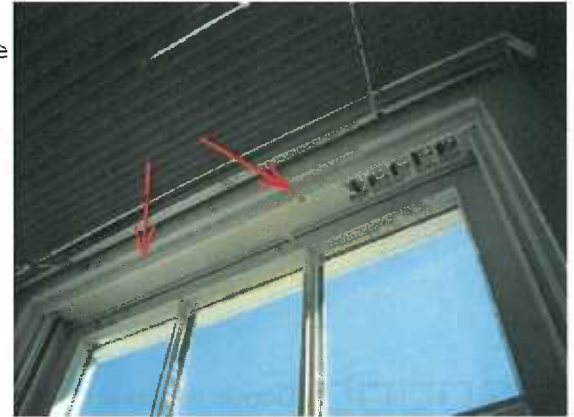
24. ☒ ☐ ☐ ☐ ☐ Walls: Drywall
 25. ☒ ☐ ☐ ☐ ☐ Floor: Carpet
 26. ☐ ☐ ☐ ☒ ☐ Windows: Andersen Double Hung, Tilt & Wash There is a stain on the top inside vinyl of this window.

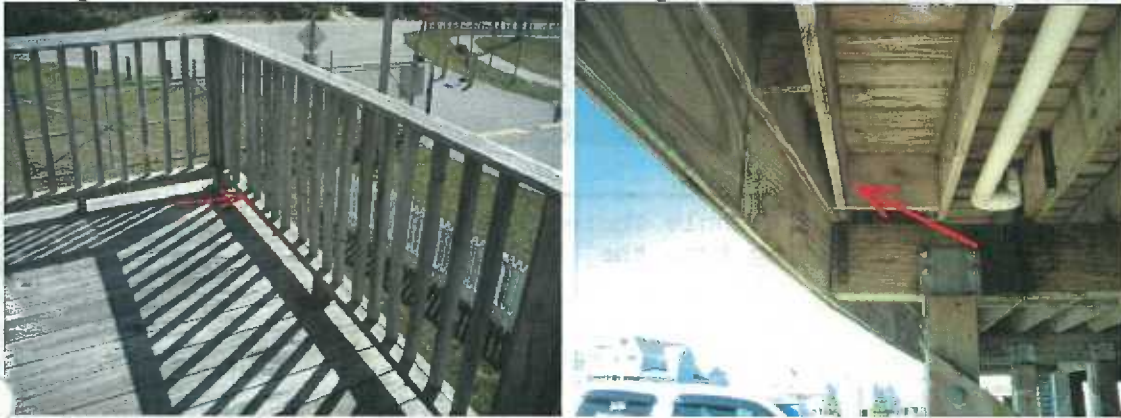
1. **Deck: Front, Pressure Treated Wood** There is one floor joist near the front of the deck that is not properly supported with a metal joist hanger. Several of the handrail pickets are loose and out of place. Close inspection revealed that the nails used to fasten the pickets to the top and bottom rails are rusty and deteriorated and failing to perform their intended function.

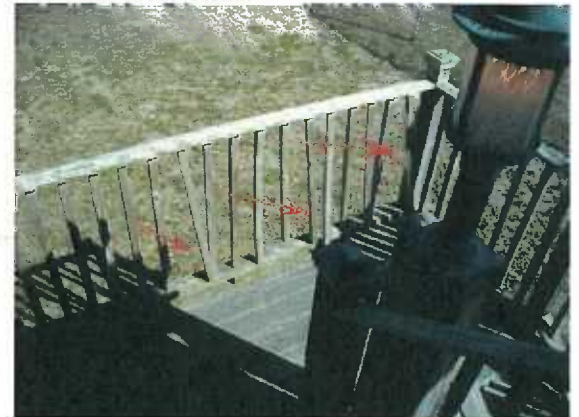
2. **Stairs/Landing: Rear Stairs & Landing, Pressure Treated Wood** The wood pickets are loose or out of place. The nails used to secure the pickets are rusty/deteriorated.

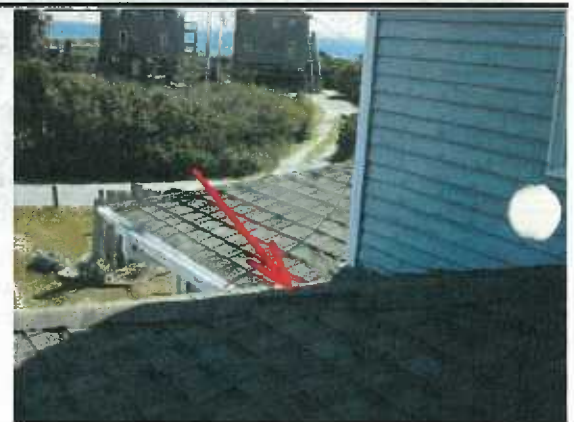
8. All Roof Areas Roof Surface Material: Asphalt shingle There are several ridge cap shingles missing from the porch roof.

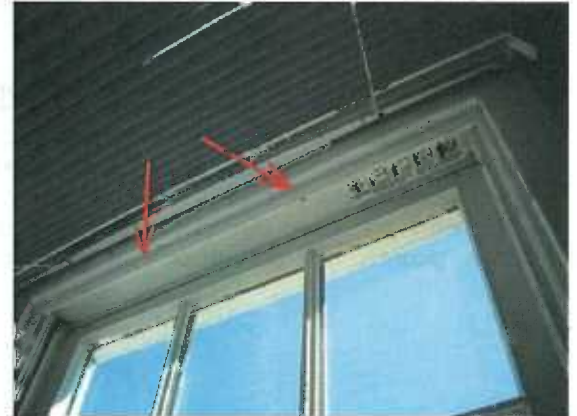
11. Stair Well Living Space Windows: Andersen Double Hung, Tilt & Wash There is a stain on the top inside vinyl of this window.

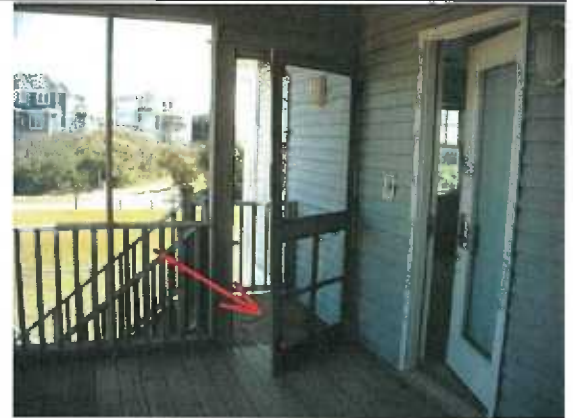
1. Porch: Rear Porch, Pressure Treated Wood The porch ledger supporting the floor joist, this girder is not bolted to the structure. Screen panels for the porch are missing or damaged. The porch screen door is damaged.

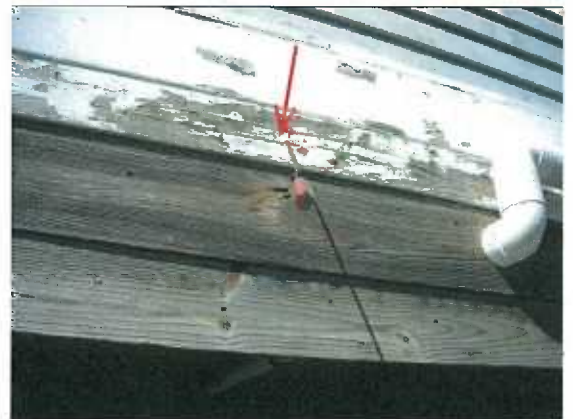
3. Trim: Wood, Aluminum Covered There is one piece of 2X4 wood trim at the lower front left corner, east side that is deteriorated and should be replaced.

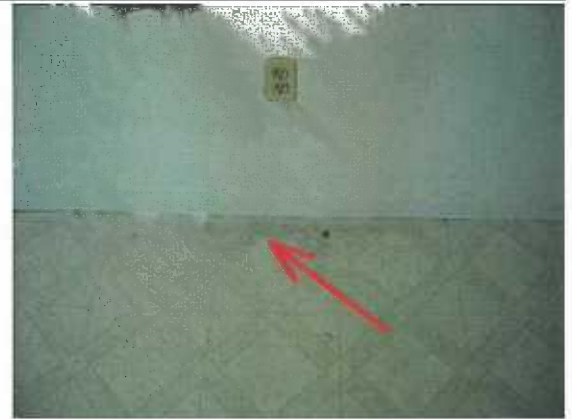
17. Kitchen & Dining Area, Main Level Kitchen Floor: Vinyl floor covering There are cut in the vinyl flooring and a stain in the area of the party wall.

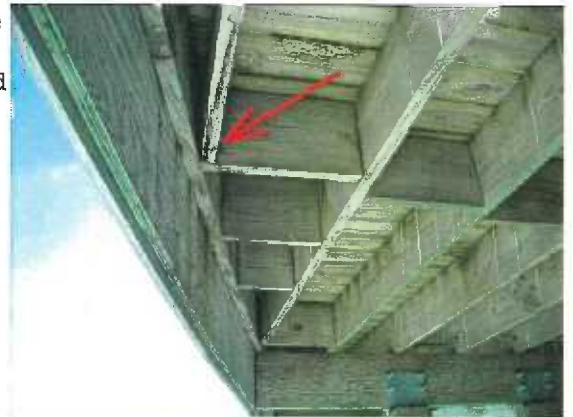
1. ☒ ☐ ☐ ☐ ☐ Walks: Concrete
2. ☐ ☐ ☐ ☒ ☐ Deck: Front, Pressure Treated Wood There is one floor joist near the front of the deck that is not properly supported with a metal joist hanger.

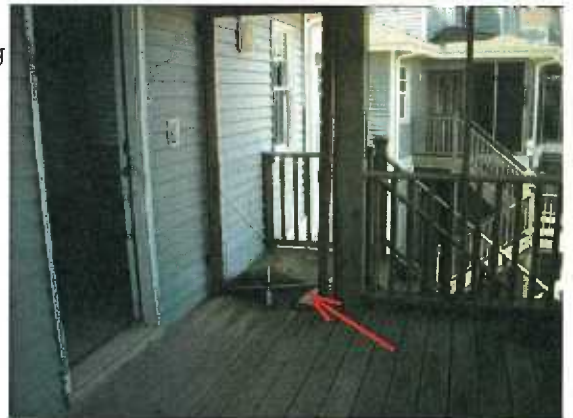
3. ☐ ☐ ☐ ☒ ☐ Porch: Rear, Pressure Treated Wood Screen panels for the porch are missing or damaged. The porch screen door is damaged.

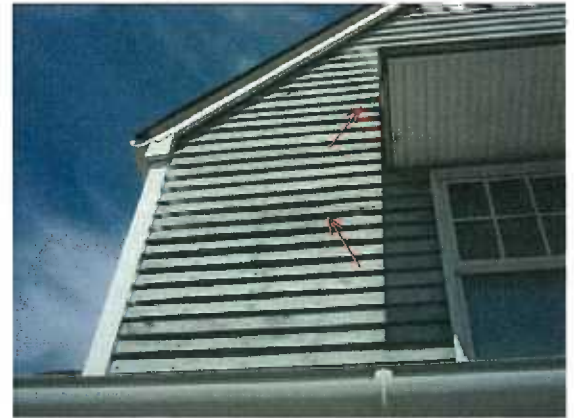
6. ☐ ☐ ☐ ☒ ☐ Type: Horizontal Wood Ship Lap Siding
All exterior wall surfaces should be examined and re nailed in the areas where is has become loose.

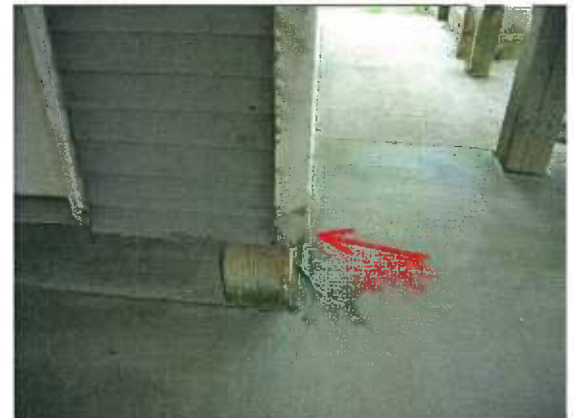
8. ☐ ☐ ☐ ☒ ☐ Trim: Wood, Aluminum Covered The aluminum covering at the lower end of the corner post in the carport is damaged.

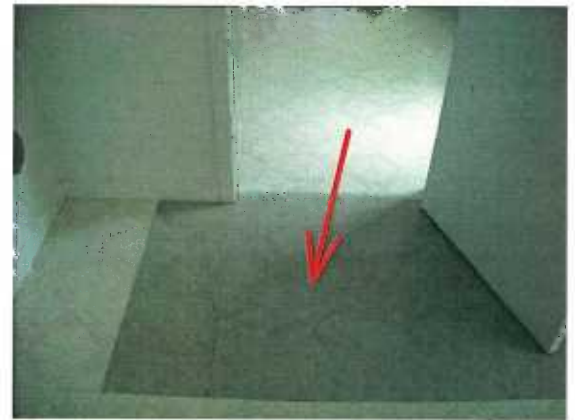
1. ☒ ☐ ☐ ☐ ☐ Ceiling: Drywall
 2. ☒ ☐ ☐ ☐ ☐ Walls: Drywall
 3. ☐ ☐ ☐ ☐ ☒ Floor: Vinyl floor covering There has been a repair made in the vinyl flooring that does not match the existing vinyl.

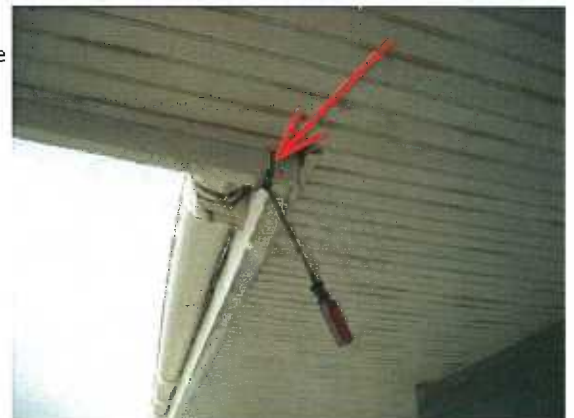
11. ☐ ☐ ☐ ☐ ☒ Fascia: Wood, wrapped with Aluminum Coil Stock The fascia is deteriorated at the intersection above the front deck.

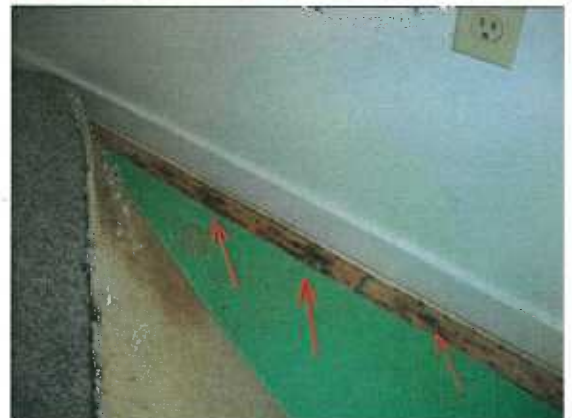
14. Top Floor Front Bedroom Floor: Carpet The carpet tack strip along the unit party wall, the strip is stained and the tacks are rusty.

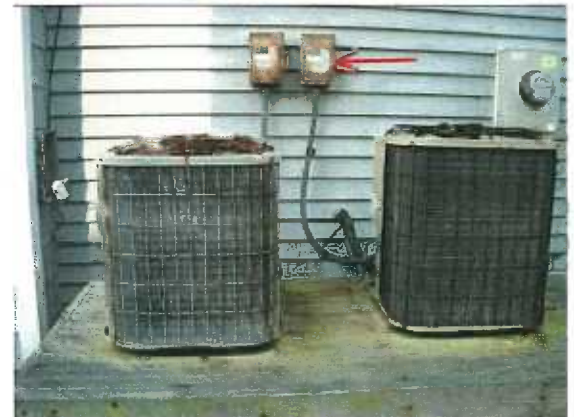
5. **East Side AC System Electrical Disconnect:** Tumble switch The HVAC electric disconnect box is very rusty.
